# HEATTREAT

## Heat treatment of fast-grown softwood

### OBJECTIVES

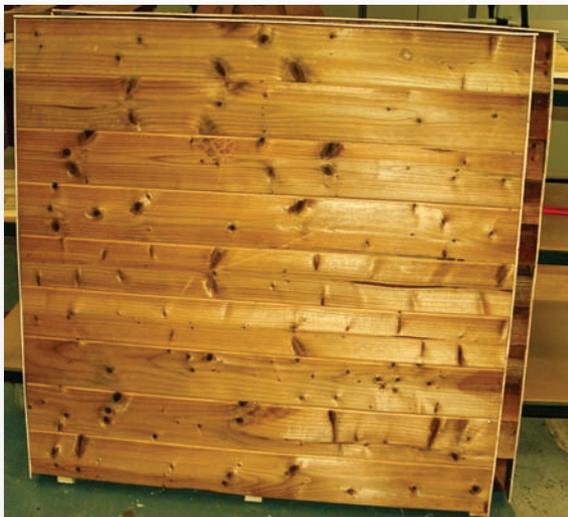
Figure 1: Nailed test panel prior to outdoor exposure.

Timber from two sources was used. The larger amount was material remaining from a large scale heat treatment trial carried out by the Wicklow Rural Partnership and consisted of Sitka spruce grown within that county. This timber was available as sawn boards with cross-section 150 x 20 mm. Machining to tongue and groove and to shiplap profiles was carried out at the Coillte Dundrum sawmills. Smaller amounts of timber remaining from the original University of Limerick heat treatment trials, and treated in the Netherlands using the Plato and Lignius processes, were also included. Power nailing was used and following insertion of each nail visual assessment of the quality of the fixing was carried out and judged as pass or fail on the basis of the quality of fixation and absence of splitting. Untreated controls were also nailed, along with the widely used western red cedar. Figures 1 and 2 show a typical panel and an edge nailing situation. Prepared panels are now undergoing

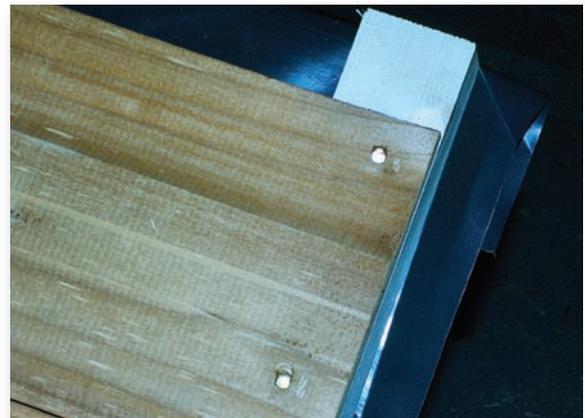
Figure 2: Extreme edge nailing presents the most severe fixing condition.

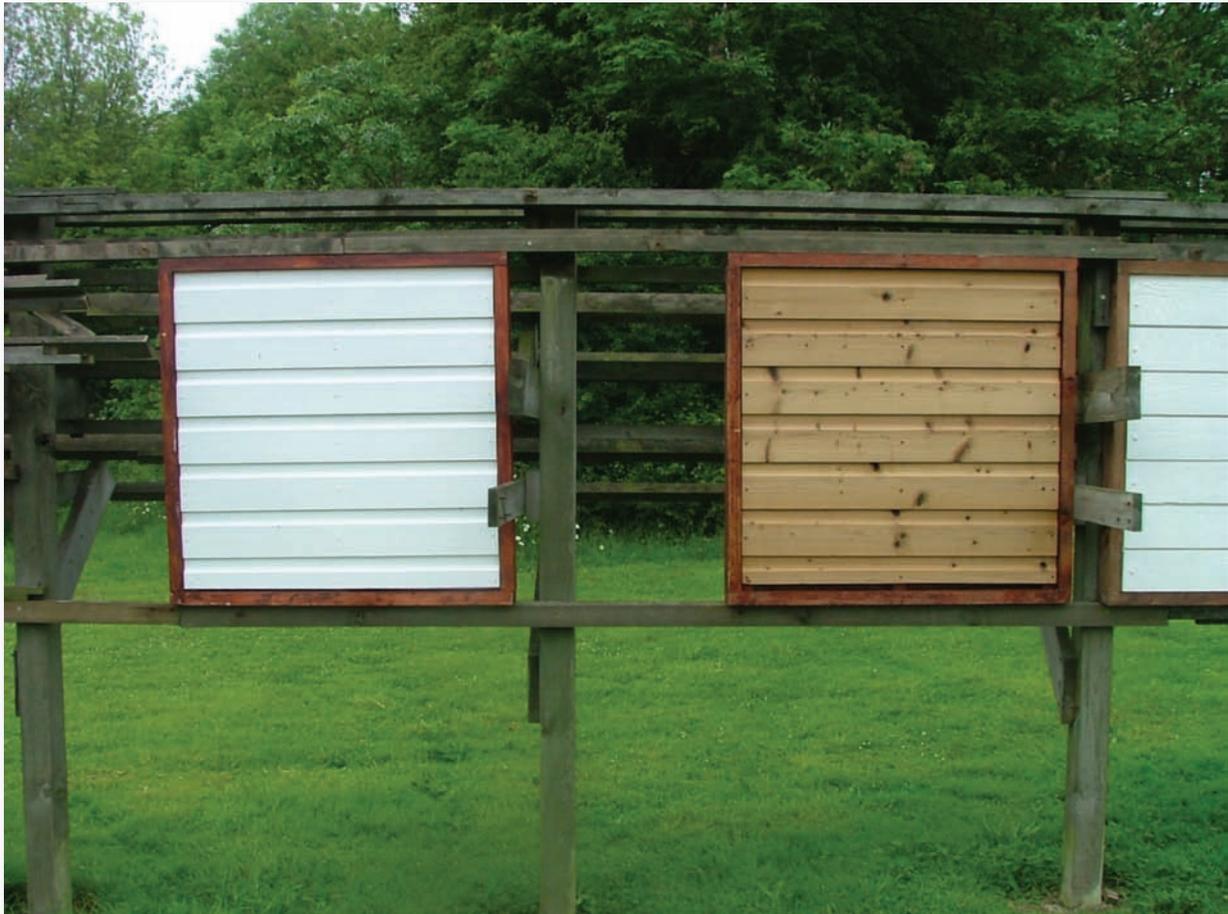
Figure 3: Panels undergoing exposure trials at the Building Research Establishment.

exposure trials at the Coillte mill in Dundrum. A small number of additional panels have also been included in an extended series of tests at the Building Research Establishment in the UK and Figure 3 illustrates these.
